**AC NO:** AC 20-64

# ADVISORY CIRCULAR

## DEPARTMENT OF TRANSPORTATION FEDERAL AVIATION ADMINISTRATION

**SUBJECT:** MAINTENANCE INSPECTION NOTES FOR LOCKHEED L-188  
SERIES AIRCRAFT

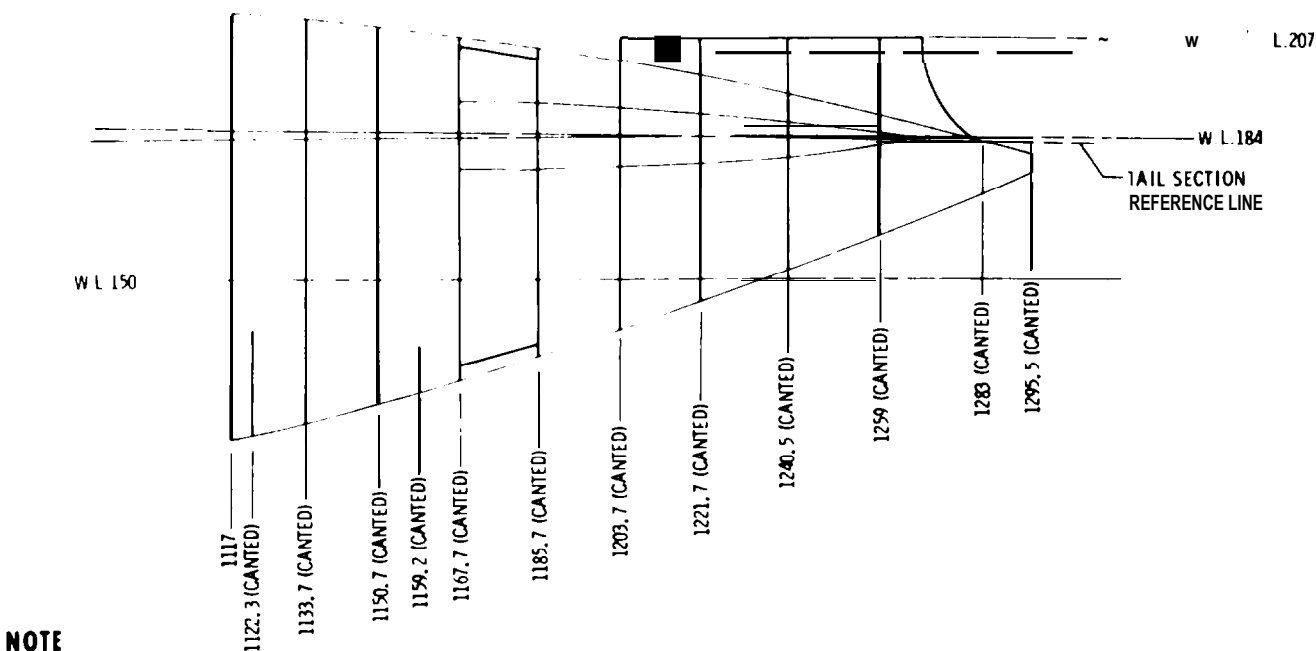
FIGURE D-4. FUSELAGE CANTED SECTION

- g. Canted Fuselage Frame Upper Web. Cracks have been found In the canted frame upper web, station 1167.7. (See figure D-4 in appendix 4, page 4.)
- SB 579  
1/31/63  
Revised SB 579A  
6/17/68  
Plus AD  
63-17-3
